## Heat flow measurements during the ATLAS End-Cup-A cold test

### 1. The set-up

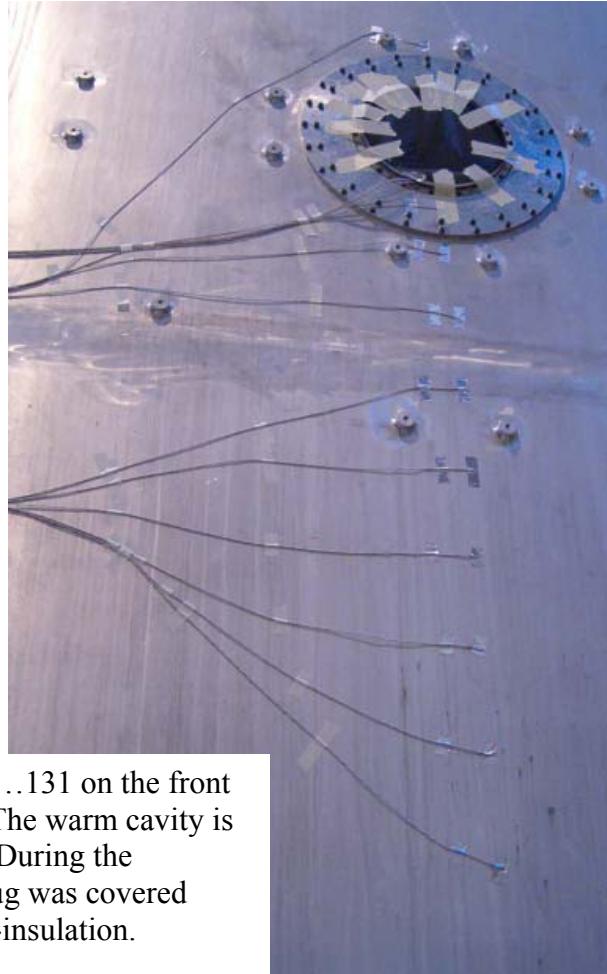
Figure 2: Probes 111...131 on the front wall of the cryostat. The warm cavity is covered with a plug. During the measurements the plug was covered with a piece of super-insulation.

**Front plug** (to close the warm tube cavity): a disk of 10 mm organic glass, with rubber joint, fixed on the flange with 3 bolts, covered by a “blanket” of super-insulation.

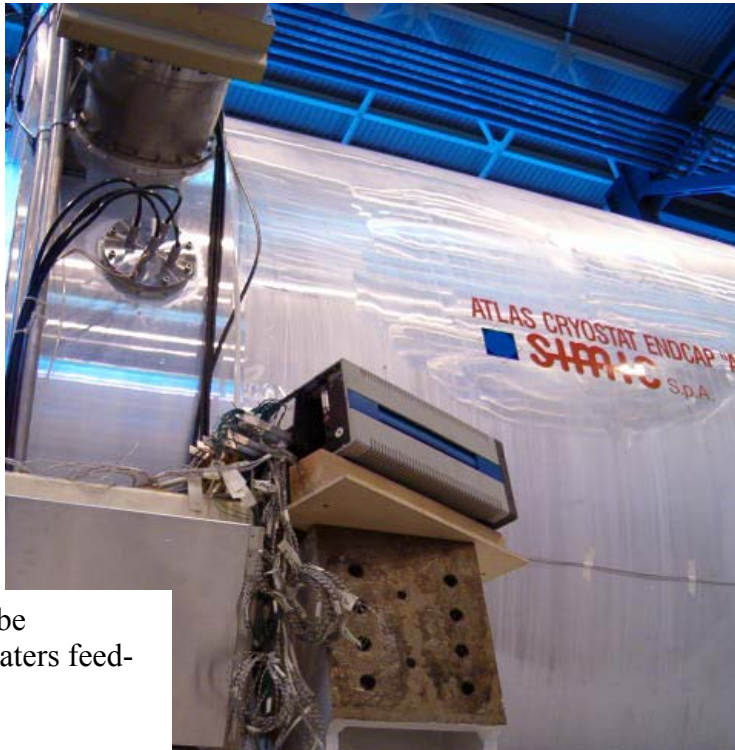
Figure 4: PT100 probe controller and the heaters feed-through.

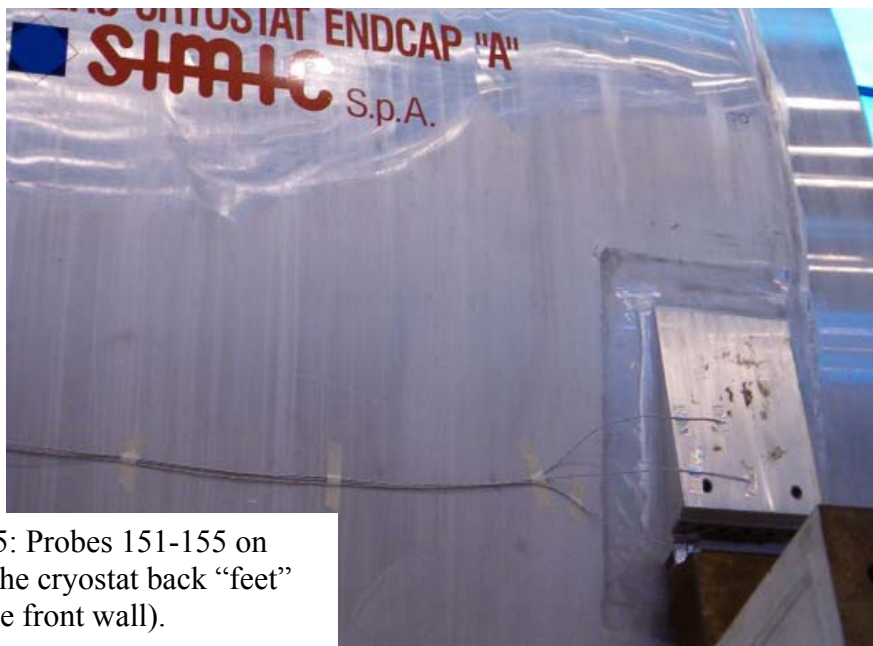
Figure 5: Probes 151-155 on one of the cryostat back "feet" (near the front wall).

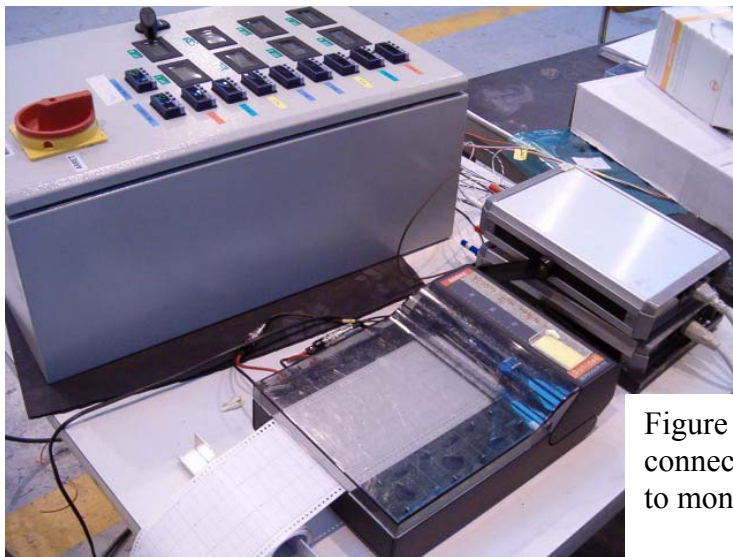
Since the DAQ did not measure the heater currents, I added digital amperimeters (3-digit KONTRONs) in series with the heaters. The voltage on the heaters could be measured manually with a multimeter. It proved to be stable within ±1.5%. The status signal (later, the direct heater voltage level) was also monitored by a standalone chart recorder with 12 cm/h resolution. The power supply and the power measurement setup are shown in Figures 6 and 7.

Figure 7: The chart recorder connected in parallel to the heaters, to monitor the heater voltage.

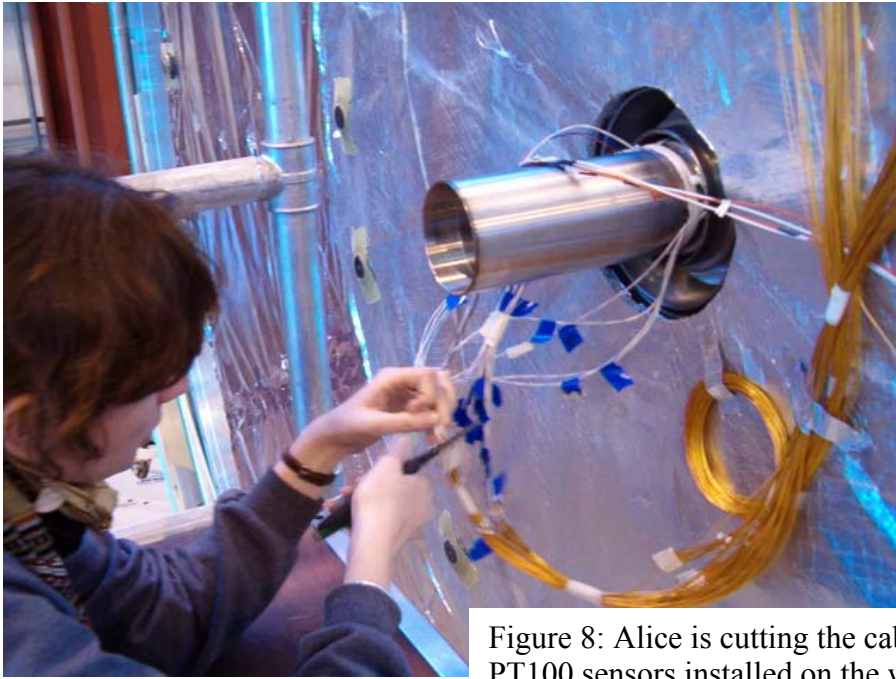
Warming-up was completed by Tuesday, March 9. The end-cup cover was opened, after cutting off the soldered edge of the warm tube. The interior of the area near the cold bellow was inspected to see if the sensors 61 and 69, which were suspected to fall off, are in place. Fig. 8 shows Alice cutting the Axon sections of the PT100 signal cables. No visual evidence for detaching of those two sensors from the inner wall of the cold tube was found. I use the term “evidence” because the sensors themselves could hardly be seen (personally, I could not – but About claimed that he saw that the aluminium scotch tape fixing the sensors was intact).

Figure 8: Alice is cutting the cables going to PT100 sensors installed on the warm and the cold tubes. All these cables were wound around the warm tube and filled the space near the edge of the cold tube.

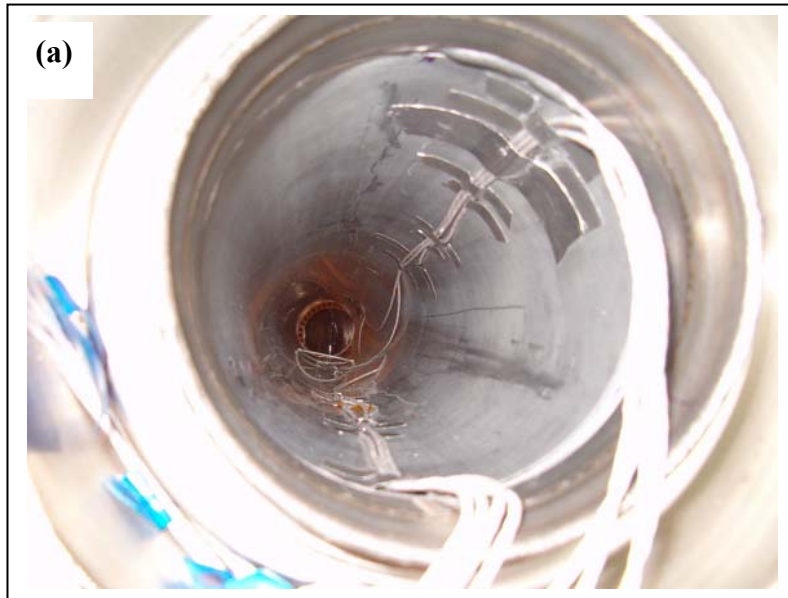
On Wednesday, March 10, the warm tube was removed and we could inspect the interior of the cold tube directly (Figures 12 and 13). Indeed, the sensors 61 and 69 seemed to be properly glued. Alice said she did not see any anomaly in the way they were attached..

Figure 12: (a) A view of the cold tube, after removal of the warm tube; (b) the area near the cold bellow, with sensors 61 (violet arrow) and 69 (yellow arrow). The spacer was located in 15 cm from the edge of the cold tube.

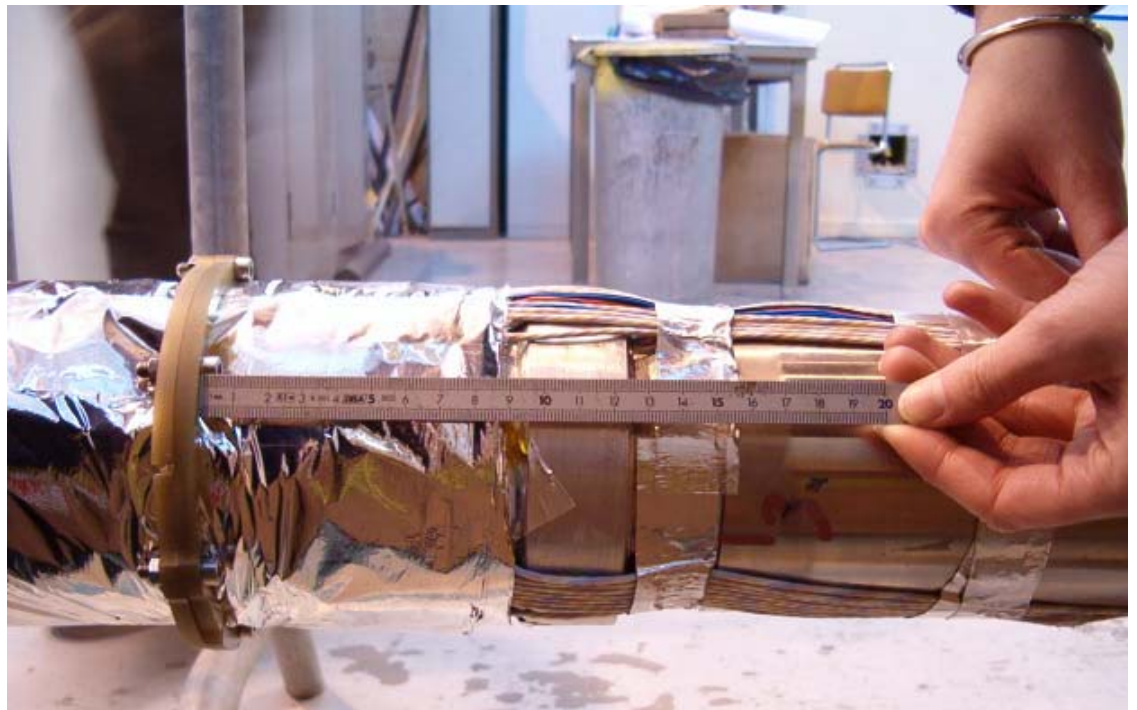
Finally, Figures 14 and 15 show the narrow end of the warm tube. Another personal observation I made concerned the spacer. As Fig. 15 shows, the points where the spacer touches the cold tube are half-filled with steel bolts. I thought that isolating bolts would be more appropriate here.

Figure 14: The warm tube. The 6-mm thick ring of the bi-metal junction, located in 11 cm from the spacer, is seen. A bunch of wires (PT100 probe signals, heater power) make the narrowest gap between the warm and the cold tube. The cold sensors 61 and 69 were located in about 5 cm from the spacer.
